AMMRC CR 70-5 (F)

**FEASIBILITY STUDY
OF COLUMBIUM ALLOY CASTINGS**

R. J. BEAUREGARD
Avco Lycoming Division
Stratford, Connecticut 06497

FINAL REPORT — CONTRACT NUMBER DAAG46-69-C-0163

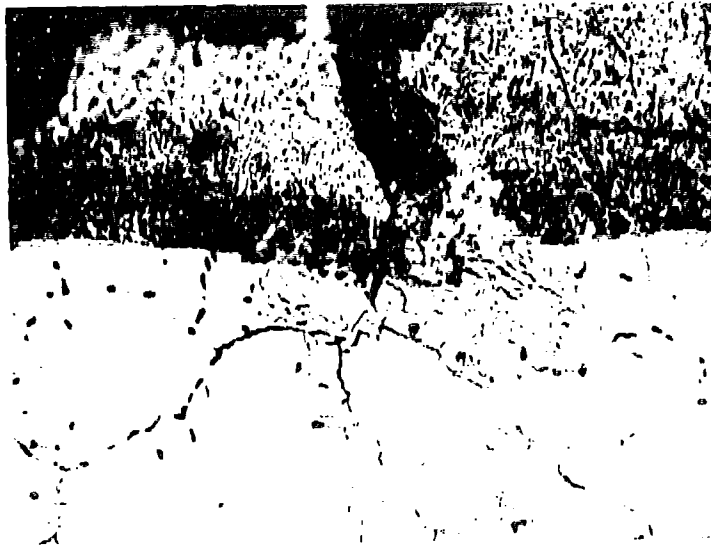
Figure 44. Relative Degradation of VH 112 Coating on C-3015.

Leading Edge

Microexamination of VH112 coated C-3015, which appeared visually to be the least degraded specimen after 120 hours of testing, revealed substantial oxidation of the coating on the paddle. The local oxidation in the coating appeared to be associated with previously cracked areas (Figure 44), although it is reasonable that additional cracks occurred in the coating during testing. Although oxidation products filled the crack, this did not prevent oxygen from diffusing along these previously cracked paths. Substrate oxidation proceeded inward from these oxidized cracks and was more substantial on the trailing edge than in other locations (Figure 44). This increased oxidation is attributed to both the relatively sharp radius of the trailing edge, which aggravates the coating/matrix thermal expansion mismatch, and the higher temperature of the trailing edge of the paddle, which was 100° hotter than the leading edge (see Figure 15). Greater magnification of the substrate oxidation is shown in Figure 45. Transverse cracking at the coating and substrate interface and subsequent spalling were somewhat less in VH112 coated C-3015 than in other specimens; this probably contributed to the better visual appearance of this coating and substrate combination.
